**ASTM E 90 SOUND TRANSMISSION LOSS  
TEST REPORT**

**C.R. LAURENCE CO., INC.**

**SERIES/MODEL: 8000**

**TYPE: Single Hung Window**

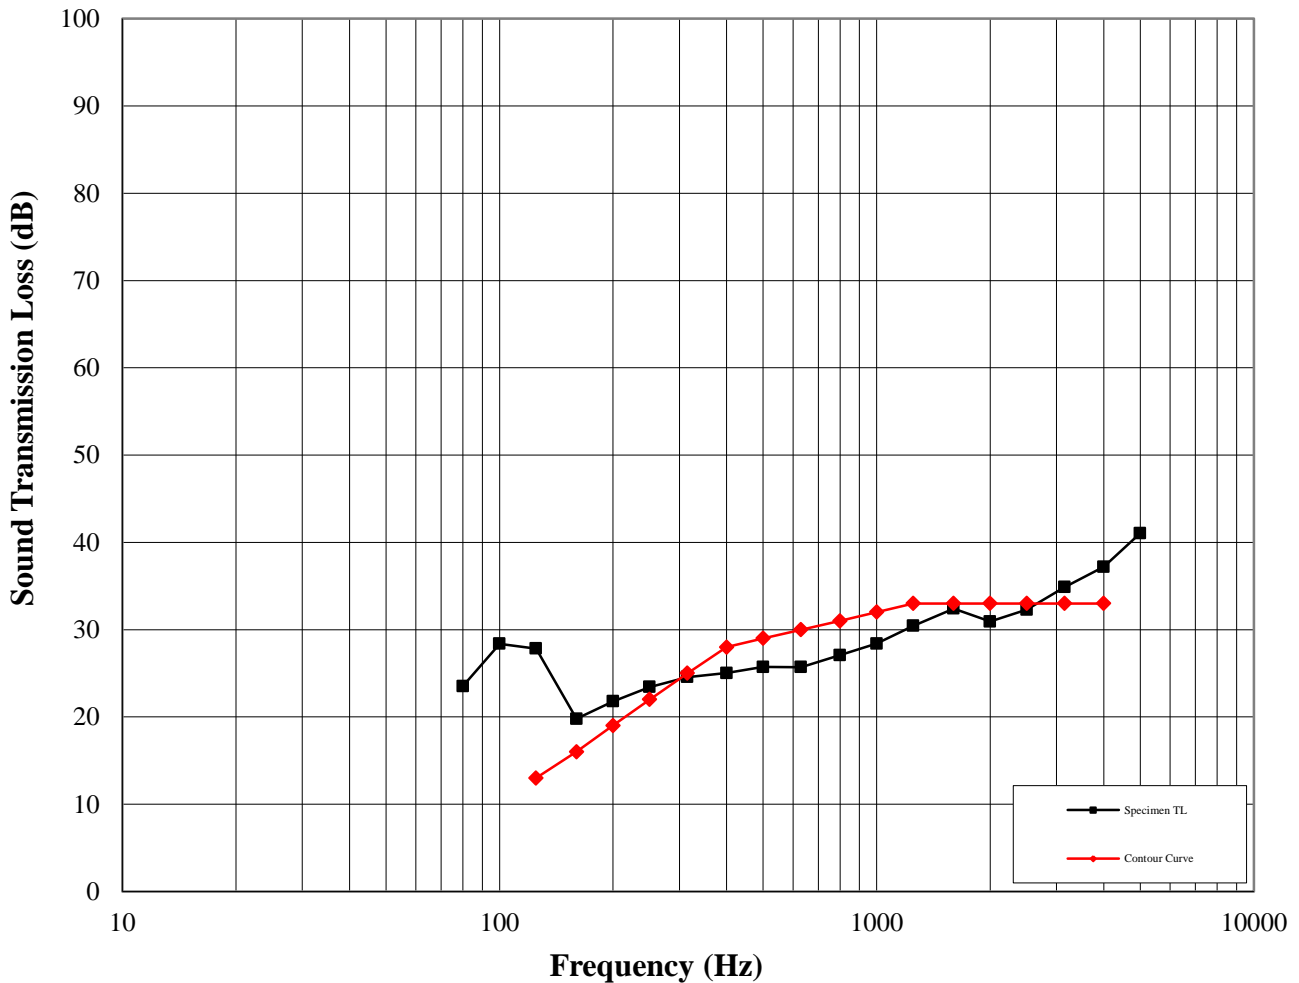
Test Date	12/30/14					
Data File No.	E2737.01					
Client	C.R. Laurence Co., Inc.					
Description	Series/Model: 8000, Single hung window with 1" IG (1/4" tempered, 1/2" air space, 1/4" tempered)					
Specimen Area	1.80 m <sup>2</sup>	Receive Temp.	22.8 °C	Source Temp.	21.8 °C	
Technician	Zach Golden	Receive Humidity	53%	Source Humidity	50%

**Airborne Sound Transmission Loss**

**STC Rating**      **29**      *(Sound Transmission Class)*  
**Deficiencies**      **25**      *(Sum of Deficiencies)*  
**OITC Rating**      **26**      *(Outdoor-Indoor Transmission Class)*

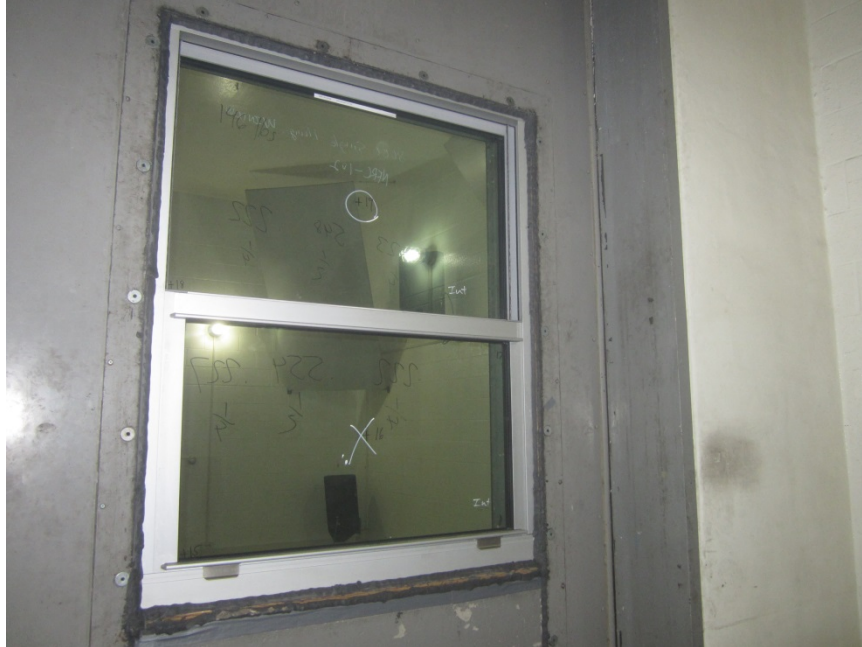
**Receive Room View of Installed Specimen**

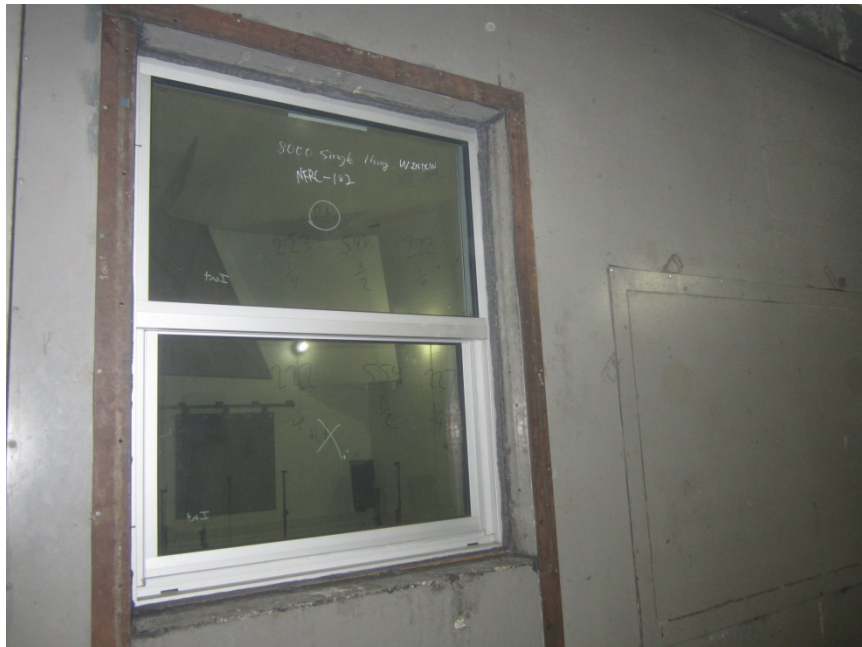
**Source Room View of Installed Specimen**
